RE: P24-0387 MICROBIAL SAMPLING &  
ASSESSMENT REPORT  
MERCER COMMUNITY CENTER  
MAX STREET  
MERCER, ND 58559

Badlands Environmental Consultants, Inc. (BEC) has completed the sampling and assessment services for the presence of mold/fungi within the Mercer Community Center located in Mercer, ND (Site). The BEC representative for this project was Environmental Specialist, Kayla DeHaven. The mold assessment was conducted on September 27, 2024 as per your authorization.

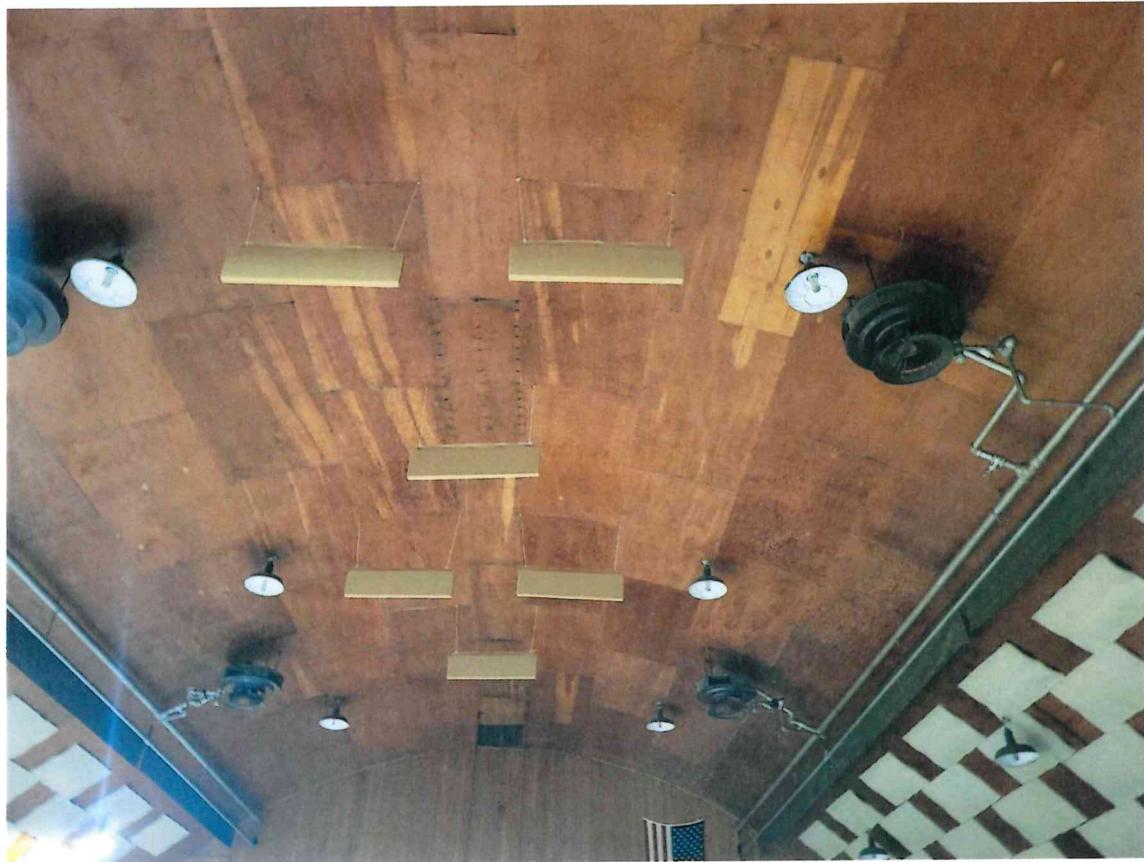
Photo 1: Visible water damage and spotting on the wood ceiling in the gym.

BEC recommends that all building materials (i.e., wood baseboards, rotted wood walls, ceilings, and door frames, insulation, etc.) should be abated, abatement of these materials should continue 2 feet past any visible water damage or mold growth. All substrate materials (i.e., intact wood walls and ceiling, wood floors, concrete walls and floors, etc.)

should be cleaned and scrubbed with an anti-microbial solution and then sprayed with an approved fungicide.

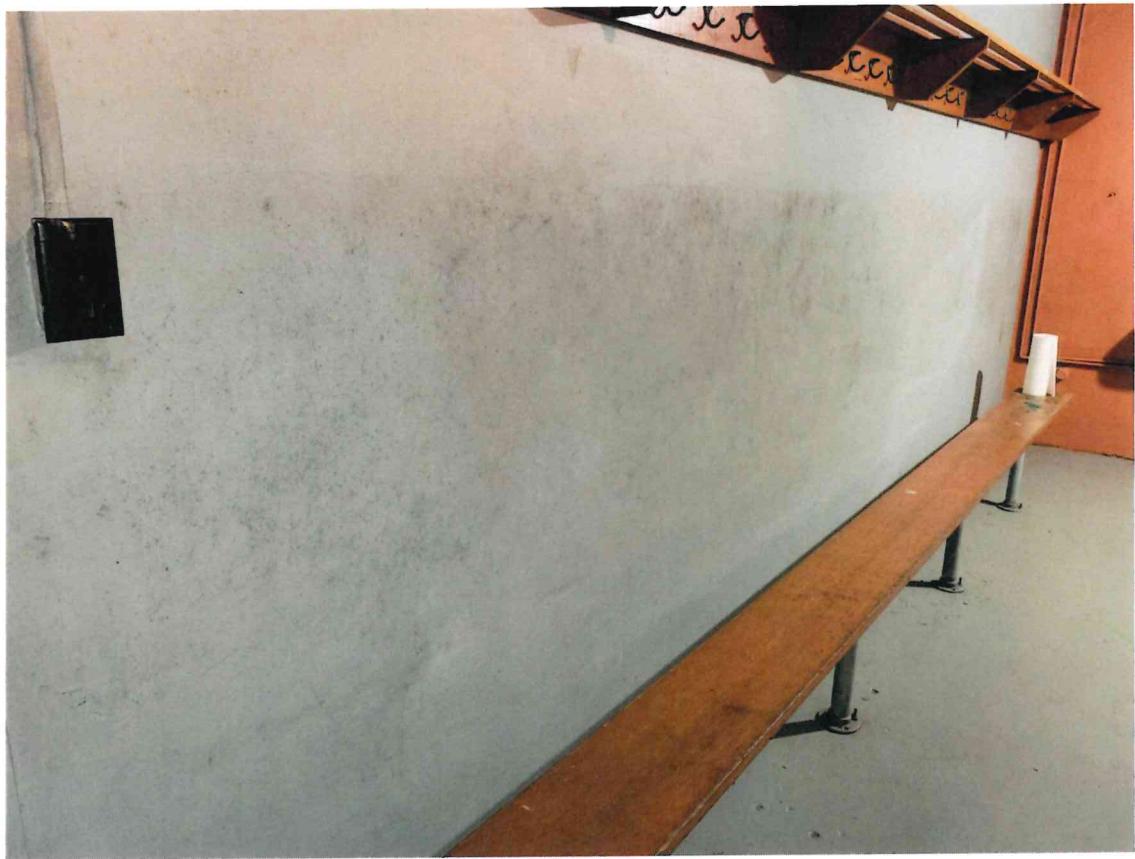
BEC observed suspect (and verified) fungal growth on the concrete walls in both bathrooms in the basement. Water damage and suspect fungal growth were also observed throughout the rest of the building on the wood ceiling, wood walls, wood door frames in the basement, etc. (see attached photos).

Photo 3: Visible mold growth on concrete walls throughout the basement.

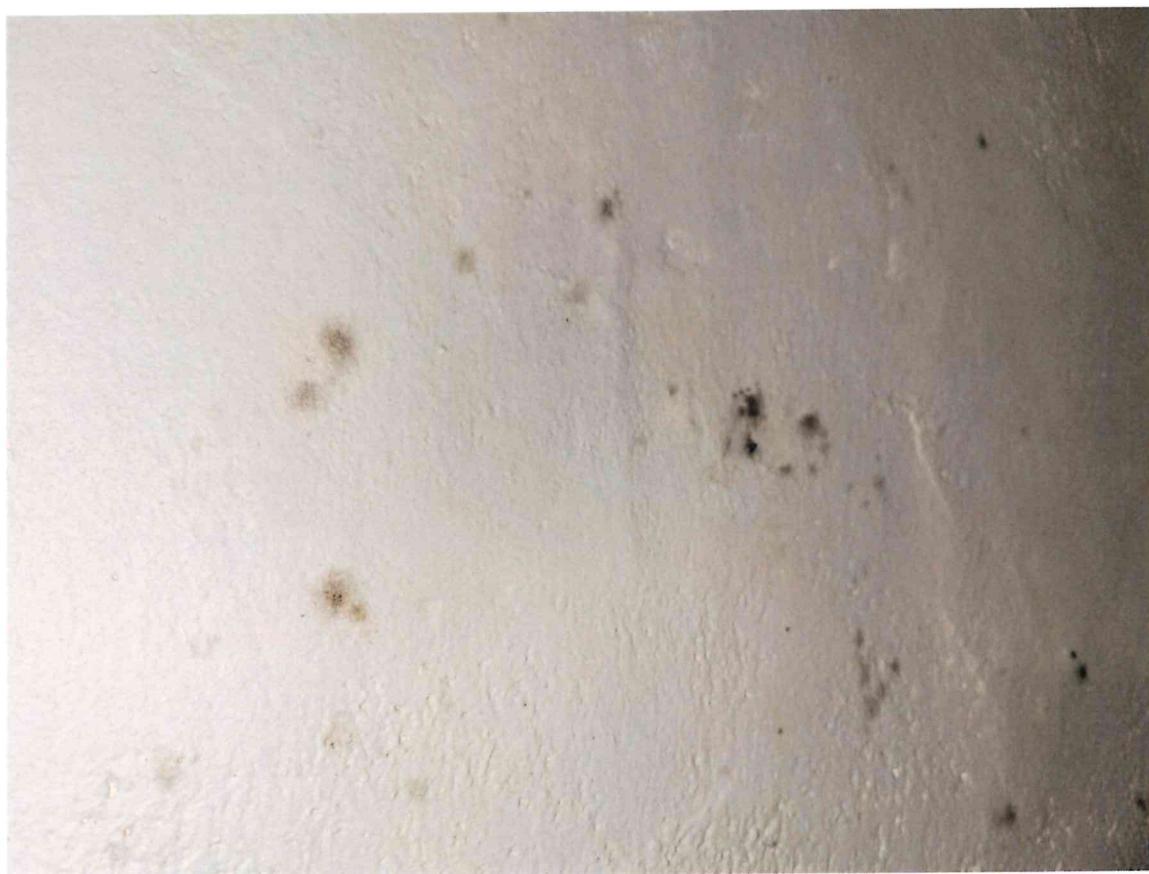
Analytical results from the surface swab sample, collected from suspect fungal growth on the concrete wall in the Women's bathroom, indicated a Moderate Presence (100- 999 spores) of Alternaria species with many mycelial detected, indicating active growth.

Photo 4: Closet up of photo 3 (Where swab sample was collected).

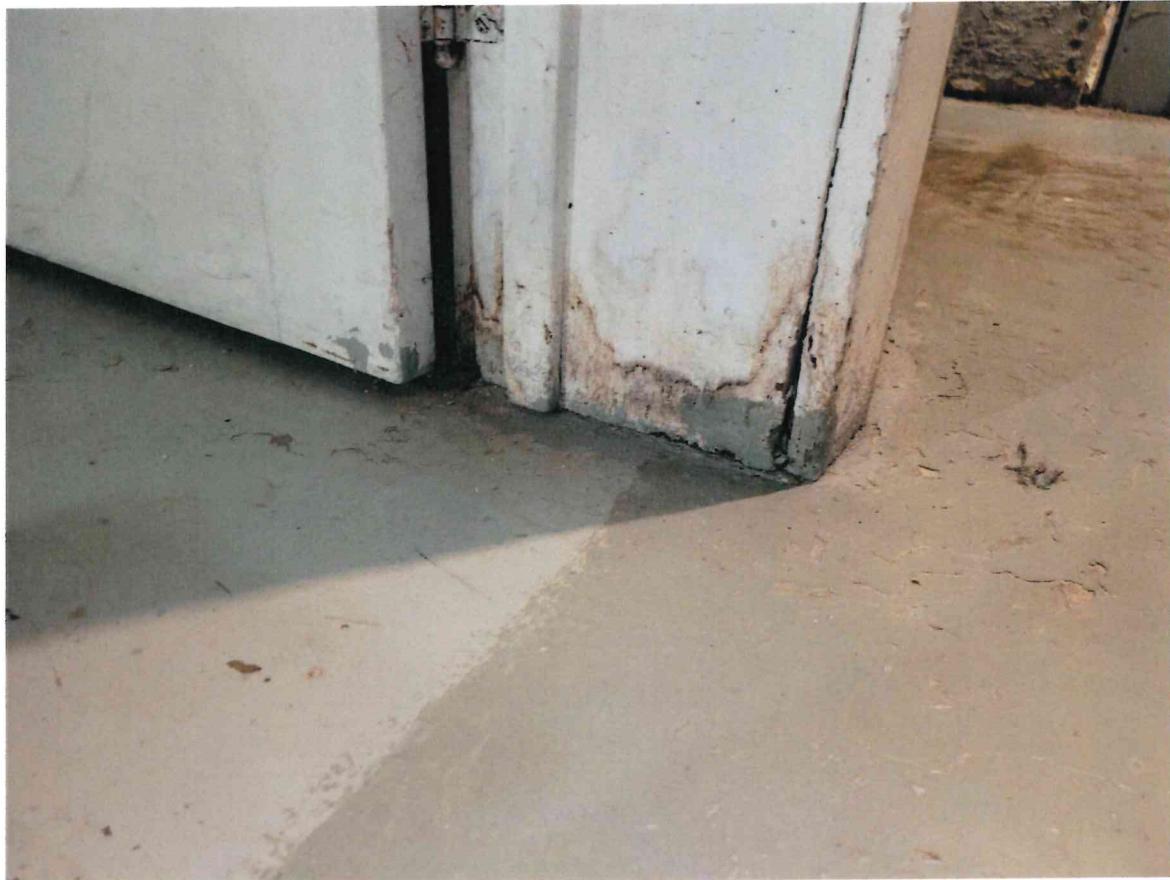
Photo 5: Visible water damage and spotting on wood door frames throughout the basement.

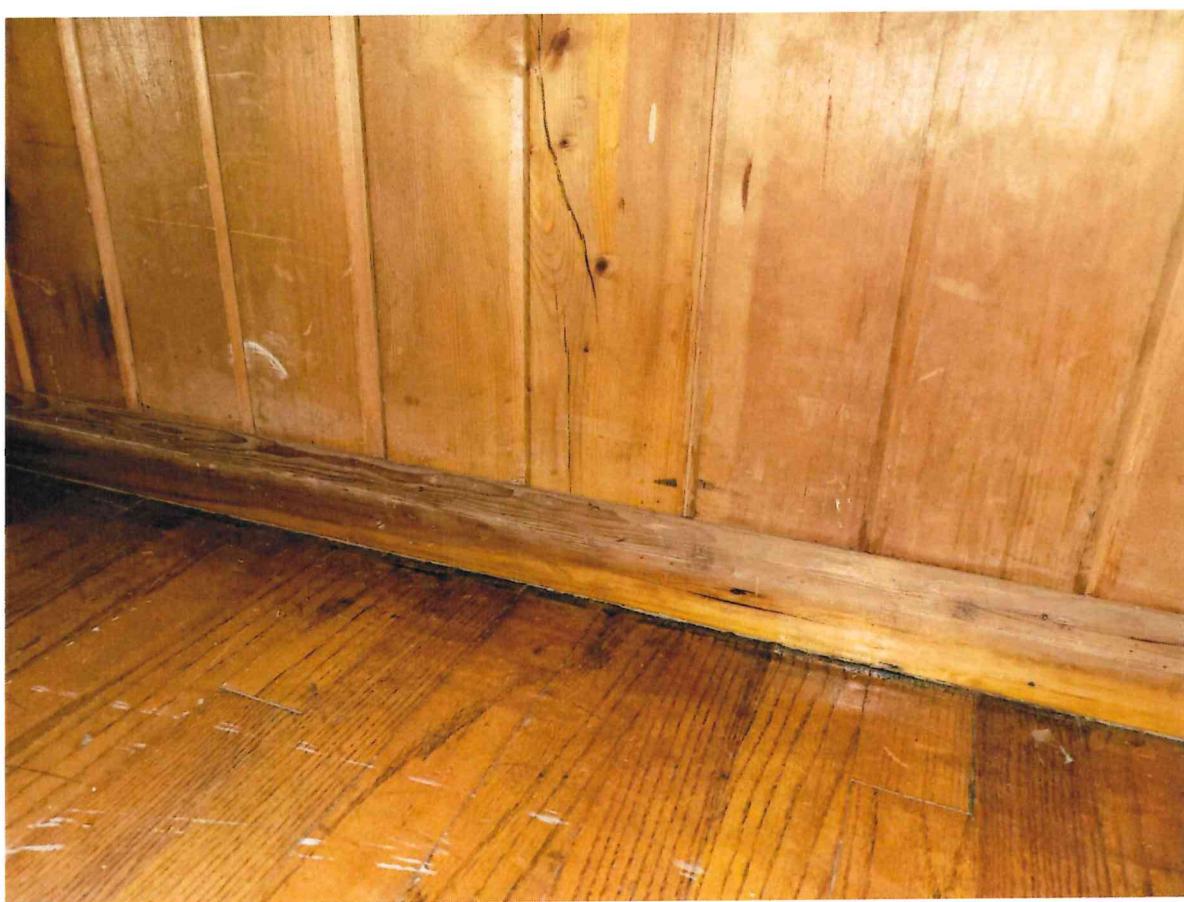
Photo 6: Visible water damage and spotting on wood walls and baseboards on the stage.
